Mattacheese Middle School
400 Higgins Crowell Road
West Yarmouth, Massachusetts

AHERA 3-YEAR RE-INSPECTION REPORT

August 2022

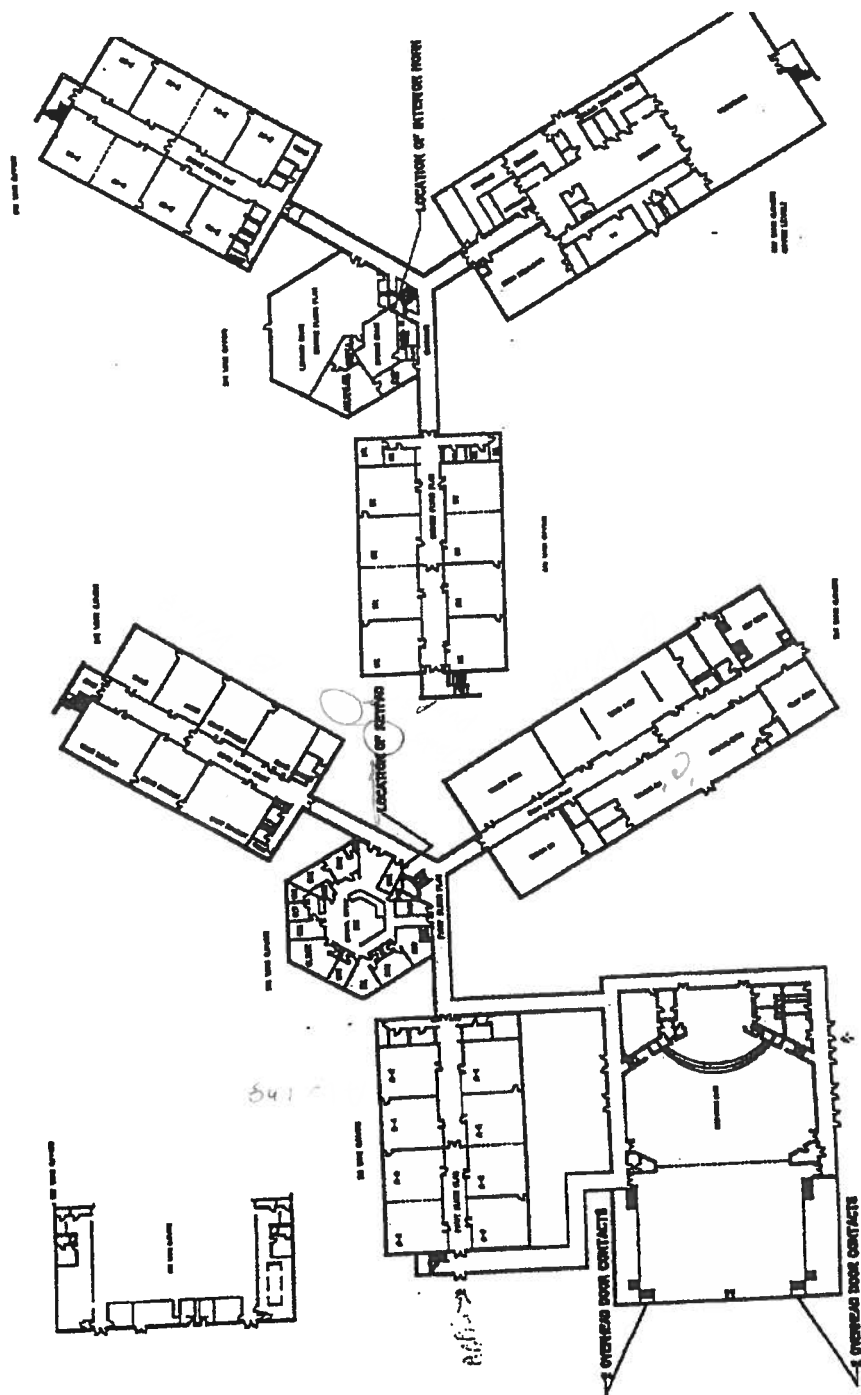
SCHEMATICS

Locations of the identified ACBMs with quantities observed, conditions assessed, homogeneous hazard assessment and changes since the previous re-inspection report are presented in Appendix A of this report.
